**OFFICE OF DEFECTS INVESTIGATION
CALSPAN ON-SITE AIR BAG NON-DEPLOYMENT FATAL CRASH INVESTIGATION
SCI CASE NO: CA09022**

**VEHICLE: 2005 CHEVROLET COBALT
LOCATION: PENNSYLVANIA
CRASH DATE: APRIL, 2009**

1. Report No. CA09022		2. Government Accession No.		3. Recipient's Catalog No.	
4. Title and Subtitle Calspan On-Site Air Bag Non-Deployment Crash Investigation Vehicle: 2005 Chevrolet Cobalt Location: Pennsylvania				5. Report Date: February 2010

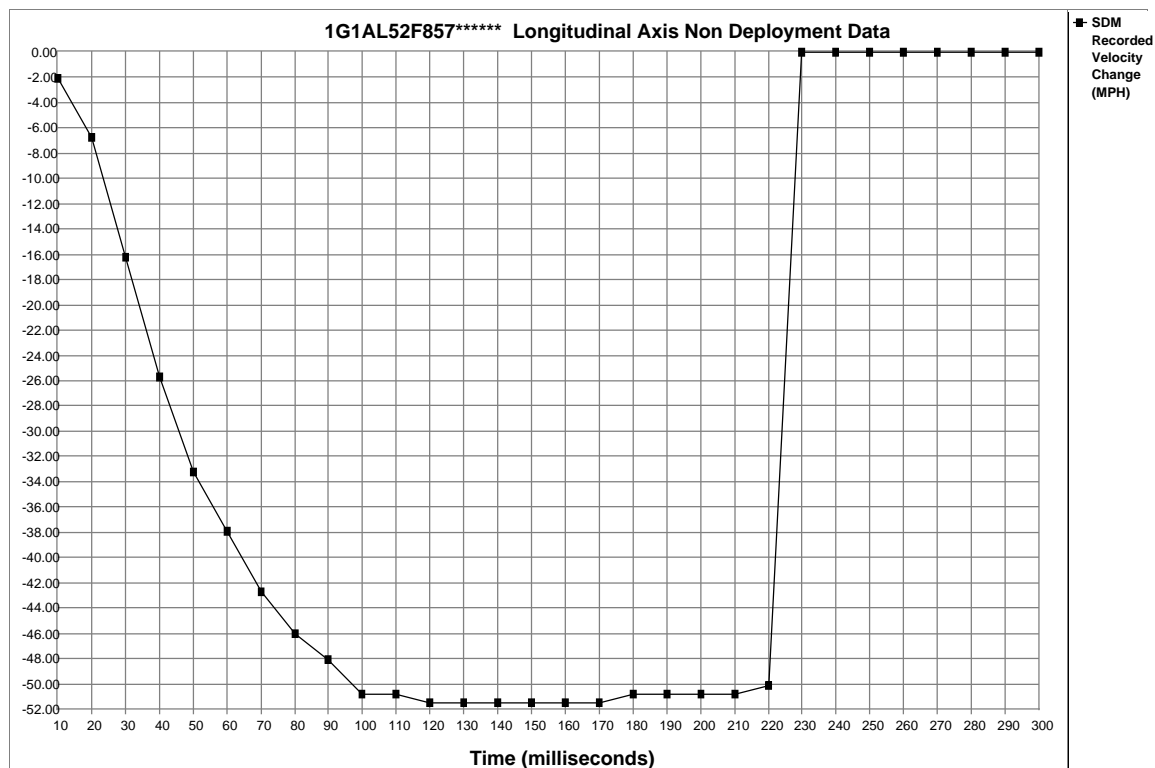
Time (milliseconds)	10	20	30	40	50	60	70	80	90	100	110	120	130	140	150
SDM Longitudinal Axis Recorded Velocity Change (MPH)	-2.03	-6.78	-16.26	-25.75	-33.21	-37.95	-42.69	-46.08	-48.12	-50.83	-50.83	-51.50	-51.50	-51.50	-51.50
Time (milliseconds)	160	170	180	190	200	210	220	230	240	250	260	270	280	290	300
SDM Longitudinal Axis Recorded Velocity Change (MPH)	-51.50	-51.50	-50.83	-50.83	-50.83	-50.83	-50.15	0.00	0.00	0.00	0.00	0.00	0.00	0.00	0.00

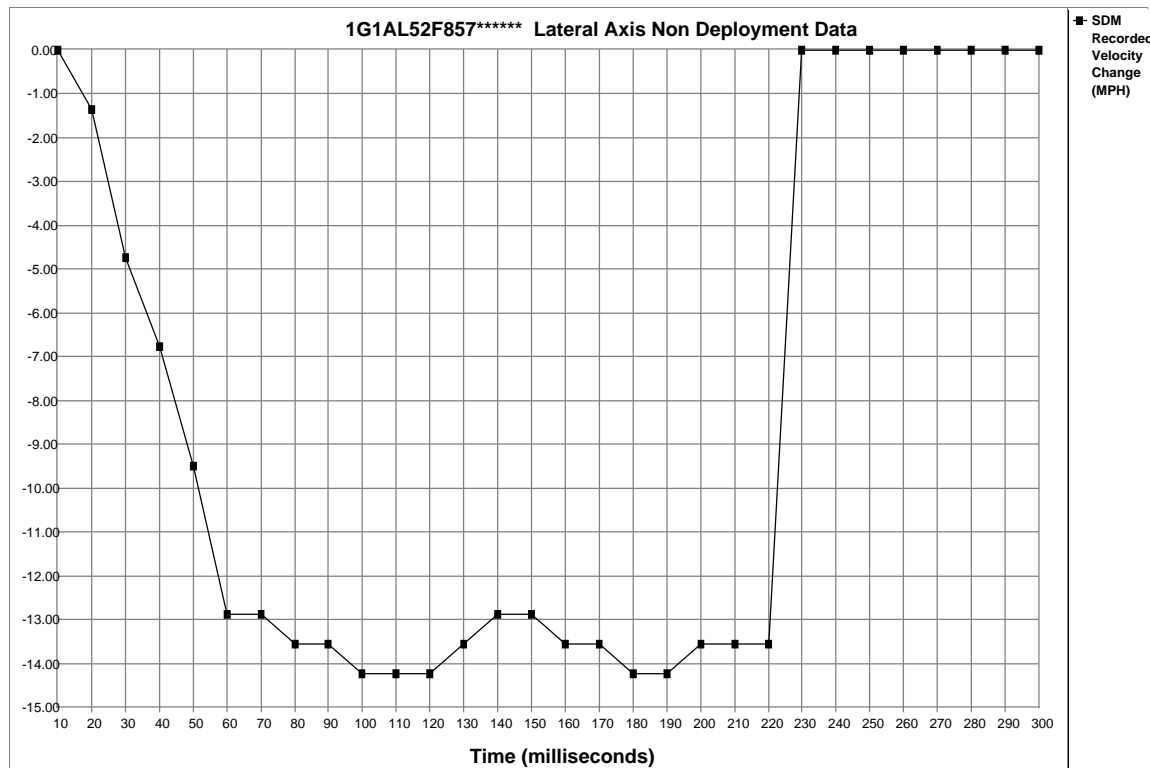
Time (milliseconds)	10	20	30	40	50	60	70	80	90	100	110	120	130	140	150
SDM Lateral Axis Recorded Velocity Change (MPH)	0.00	-1.36	-4.74	-6.78	-9.49	-12.88	-12.88	-13.55	-13.55	-14.23	-14.23	-14.23	-13.55	-12.88	-12.88
Time (milliseconds)	160	170	180	190	200	210	220	230	240	250	260	270	280	290	300
SDM Lateral Axis Recorded Velocity Change (MPH)	-13.55	-13.55	-14.23	-14.23	-13.55	-13.55	-13.55	0.00	0.00	0.00	0.00	0.00	0.00	0.00	0.00
